Marsh Landing Townhouse Condominium Association, Inc.

April 15, 2024

Subject: Building Assessment Report
Marsh Landing Townhomes
Lone Oak Drive
Estero, Lee County, Florida
Velocity Project Number: 23-259.01

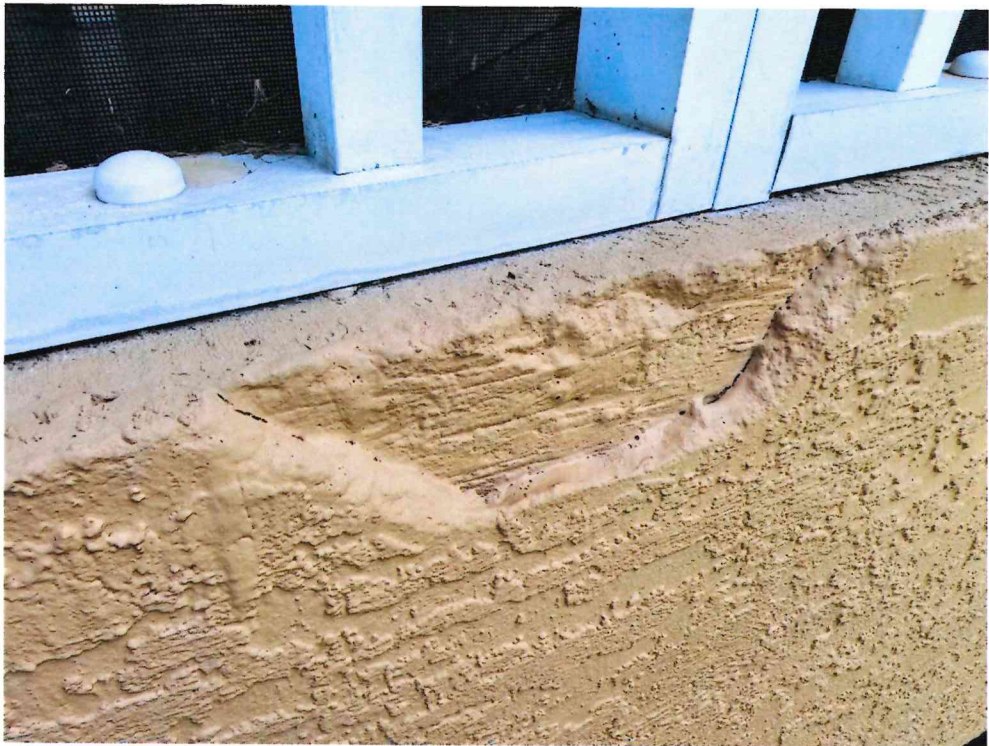
Unit 22906 – Missing and delaminated stucco on lanai slab edge

Velocity identified cracked/delaminated stucco at Units 22906, 22965, 22974, 22988, 22997, 23017, 23027, 23032, 23074, and 23084. Water intrusion can cause stucco delamination and cracking and as mentioned above, cracked/delaminated stucco may be indicative of spalling concrete beneath the stucco. Velocity recommends that the stucco at these locations be removed to determine the condition of the underlying concrete.

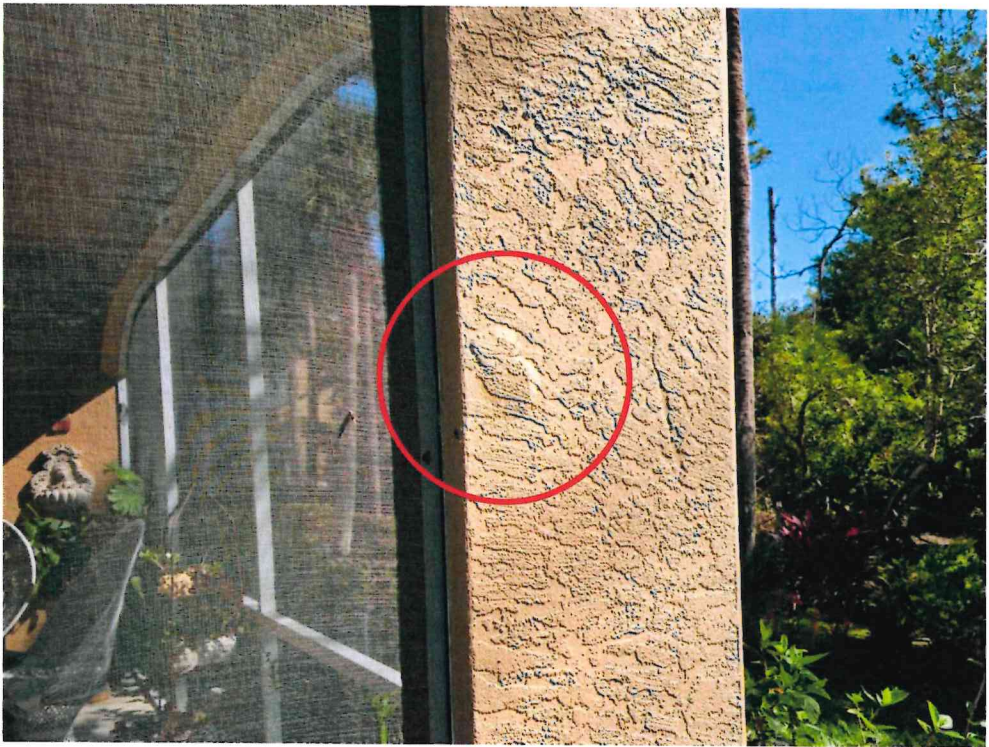
Unit 22965 – Stucco delamination on lanai column

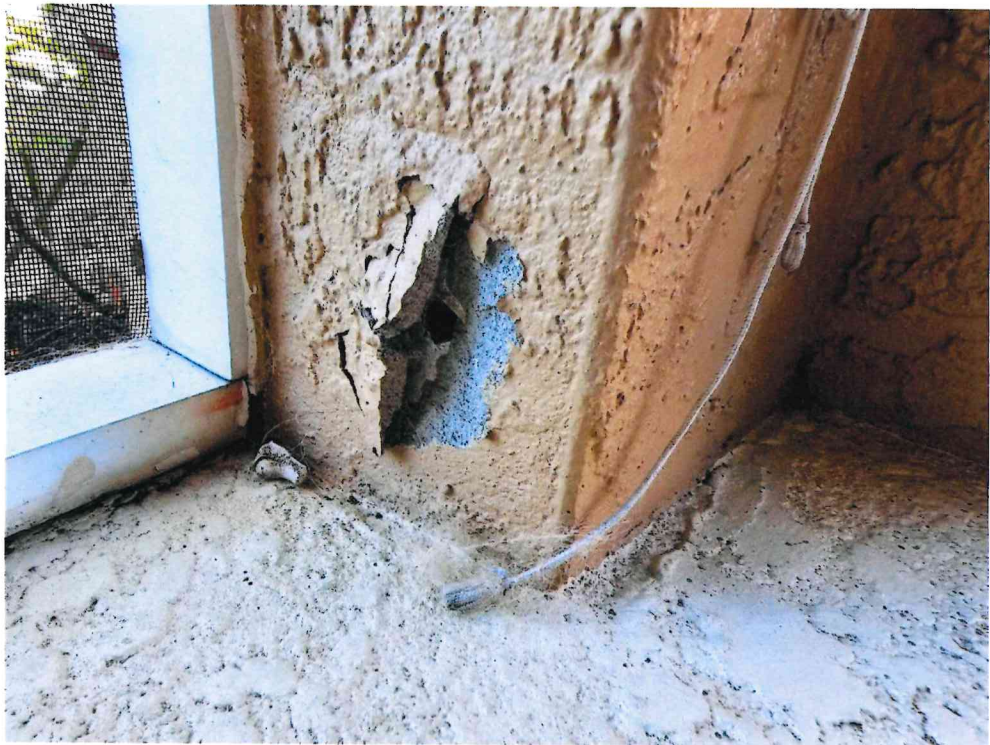
Unit 22974 – Stucco cracking and delamination on lanai column

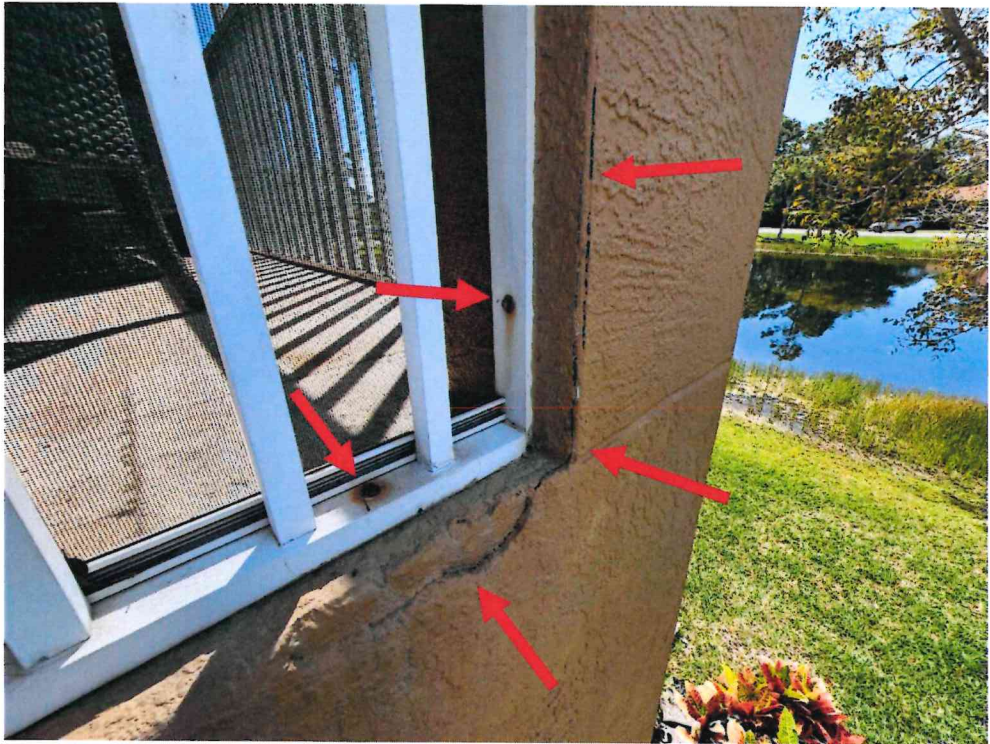
Unit 22988 – Missing and cracking stucco at corner bead on column and along lanai slab edge and rusting fasteners

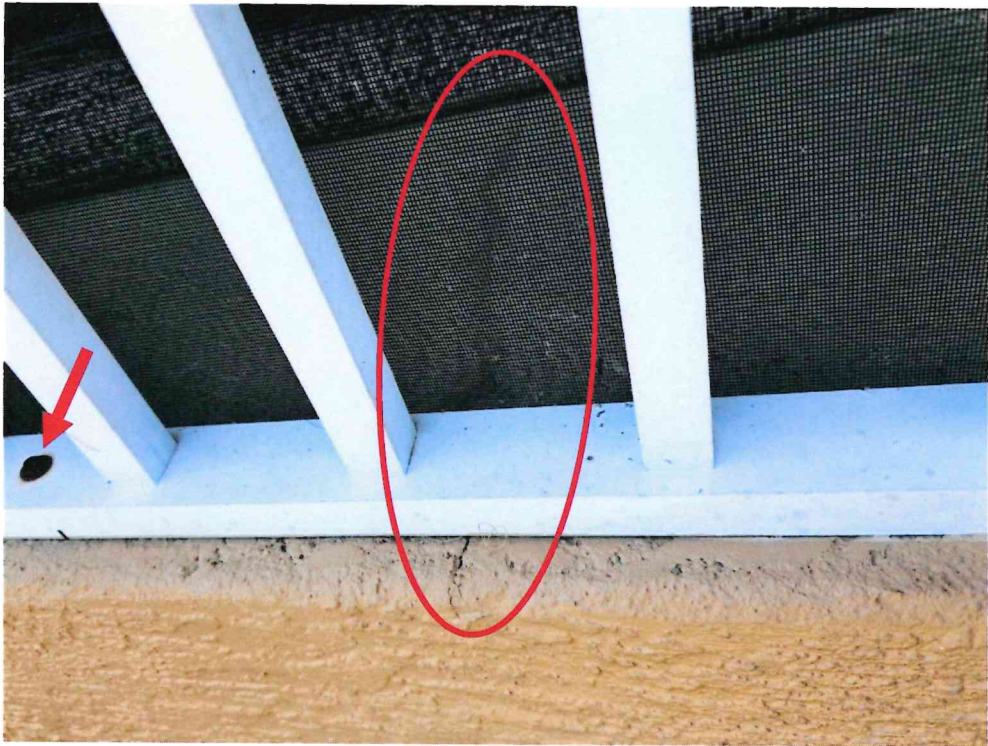
Unit 22997 – Cracking in lanai slab, stucco cracking on slab edge, and rusting/corroded fasteners

Additionally, water intrusion and the absence of a waterproof coating has likely resulted in the cracking on lanai slab surfaces and ceilings. Velocity recommends that the Association consider applying a high-performance waterproofing system on all affected lanais.

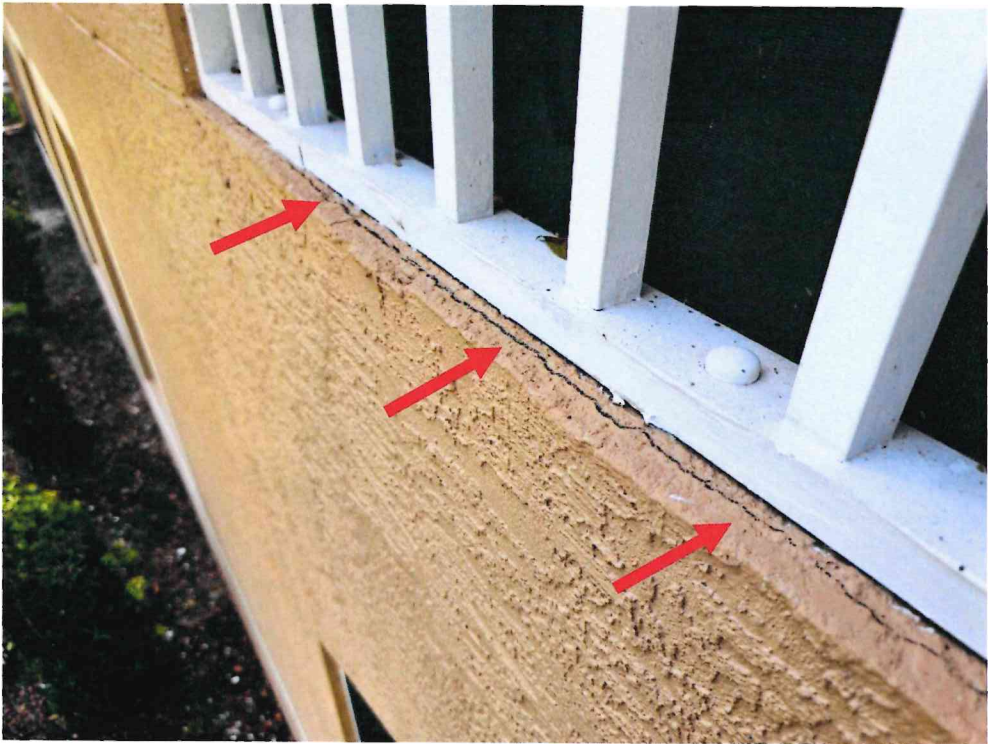
Unit 23017 – Stucco cracking and delamination on lanai slab edge

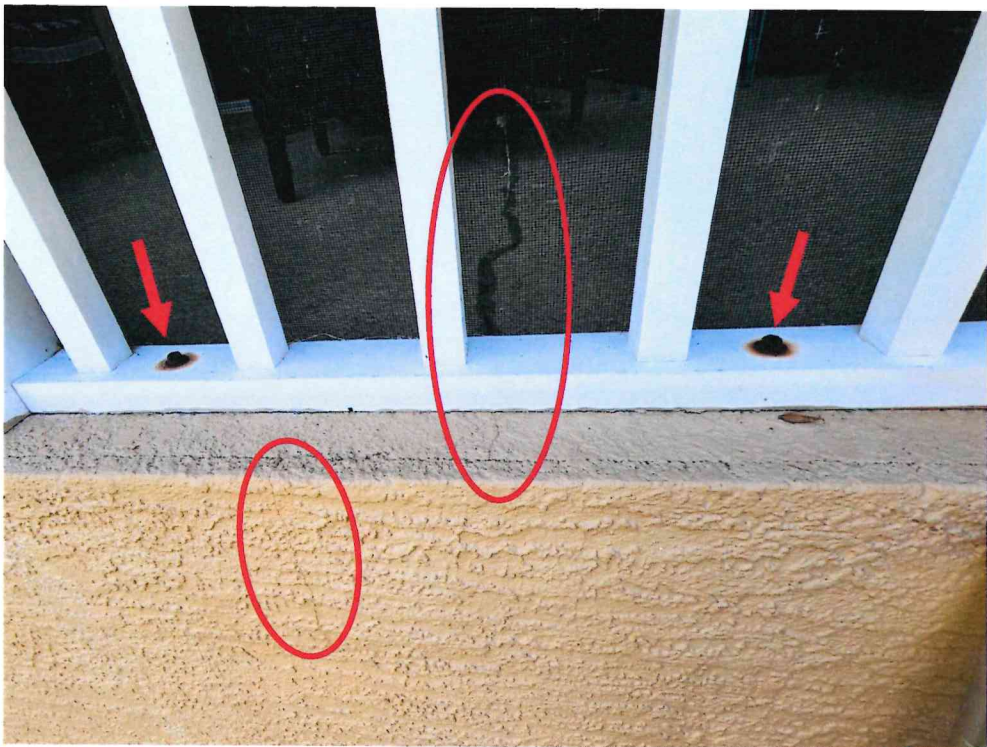
Unit 23027 – Crack on lanai slab, stucco delamination on slab edge, and rusting/corroded fasteners

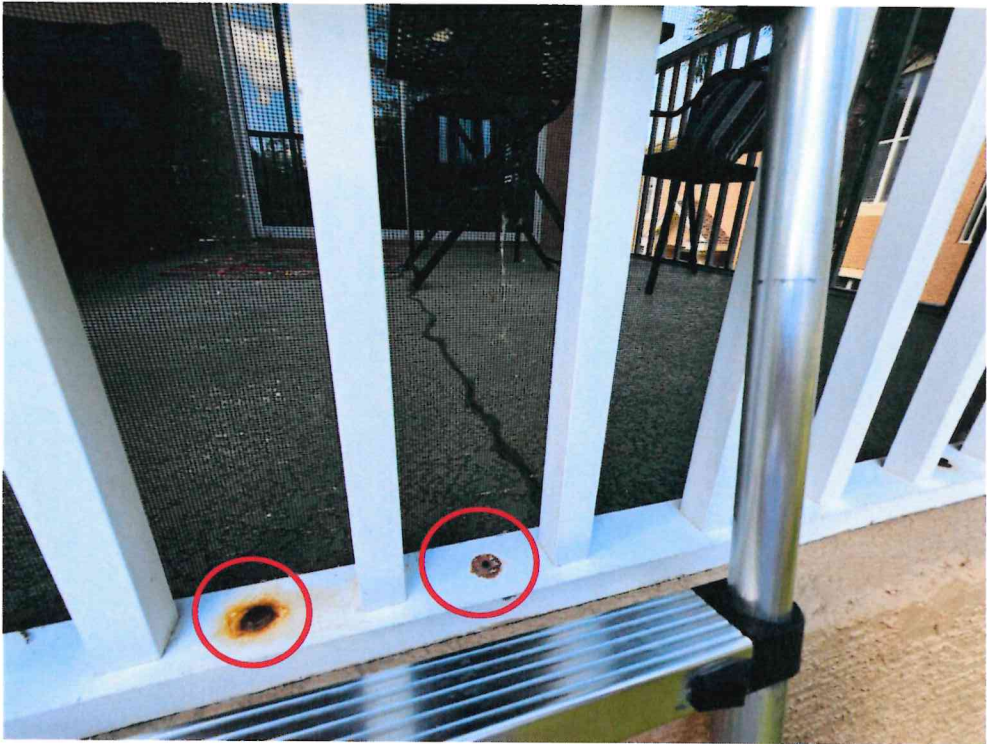
Unit 23027 – Rusting/corroded and missing fasteners

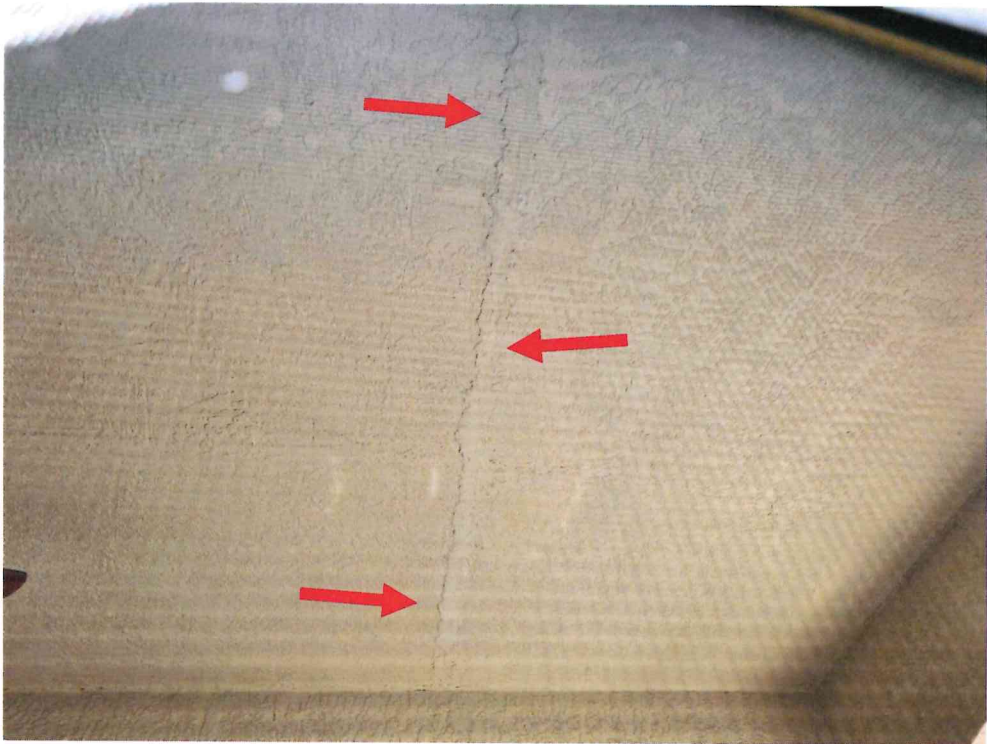
Unit 23032 – Stucco cracking on lanai ceiling along slab joint

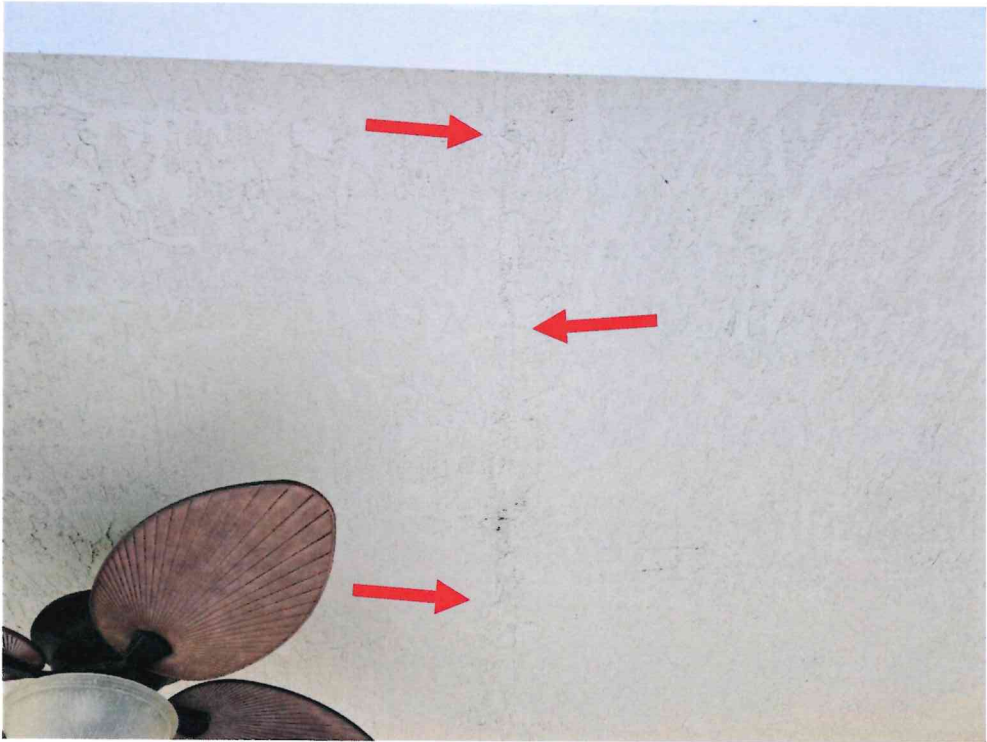
Unit 23074 – Stucco cracking on lanai ceiling along slab joint

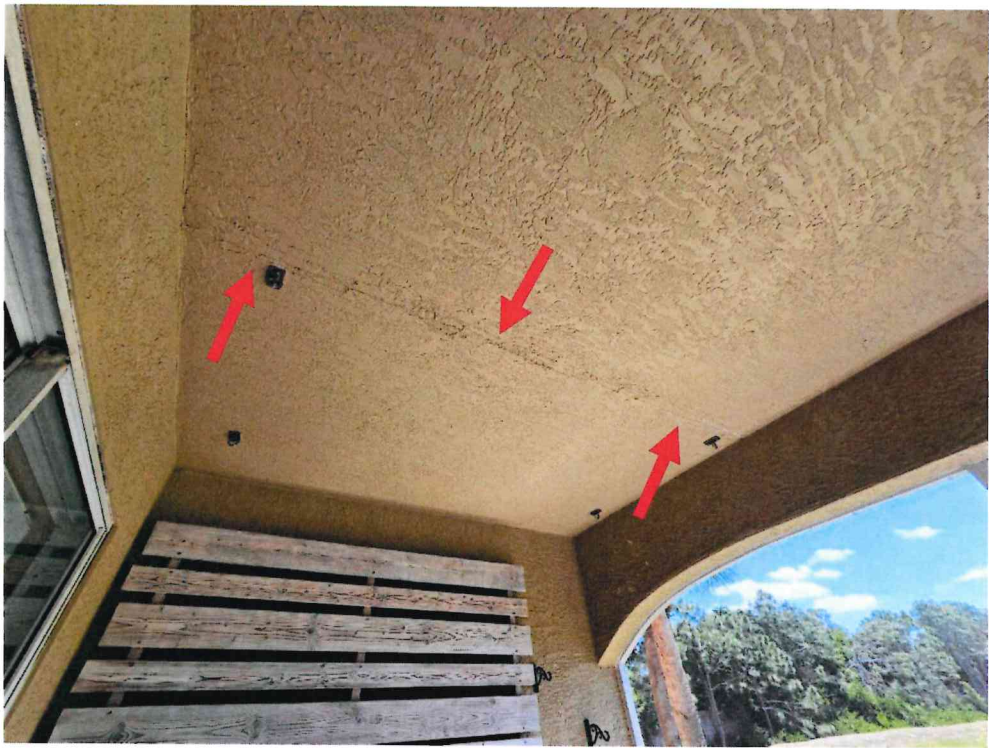
Unit 23084 – Stucco cracking on lanai ceiling along slab joint

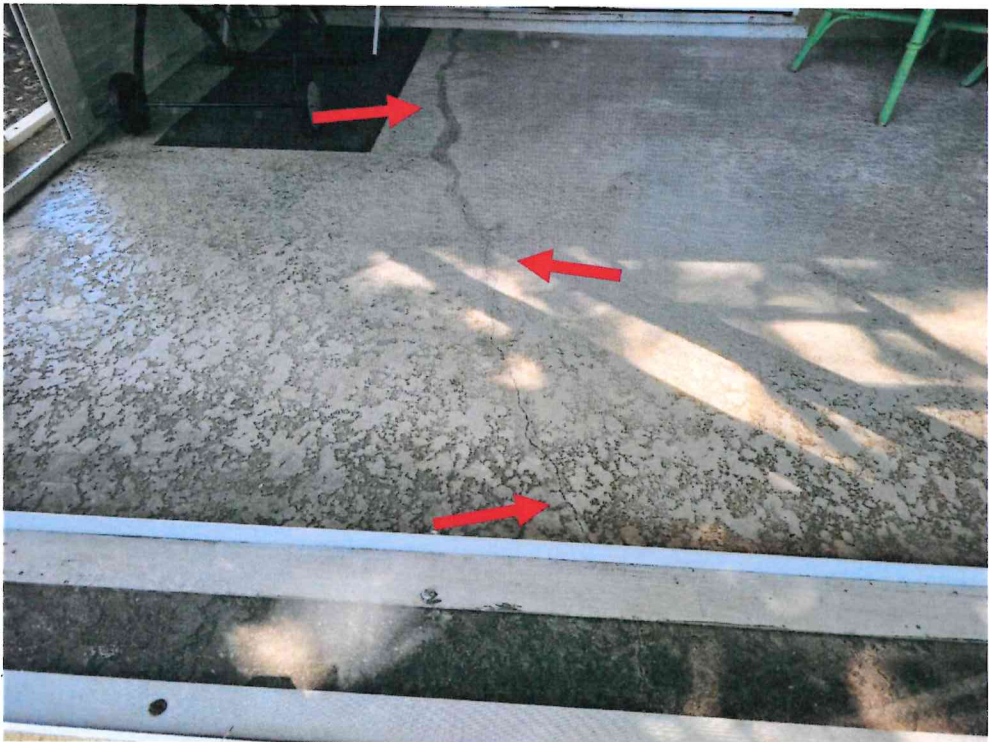
Furthermore, typical shrinkage cracking was observed on the surface of the lanai ground floor slabs at Units 22903, 22904, 22912, 22944, 22965, 22993, 23003, 23005, 23013, 23032, and 23034. Shrinkage cracking is normal for concrete as it cures and ages and is not considered to be of structural concern. *OK*

Unit 22944 – Typical crack in lanai ground floor slab

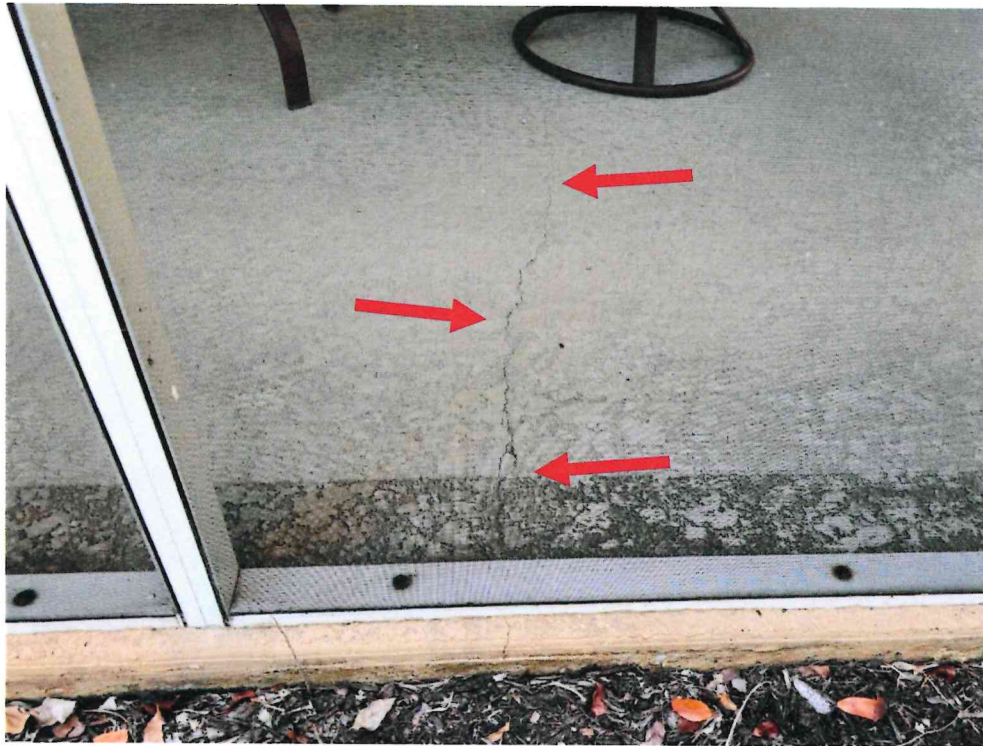
Unit 22993 – Typical crack in lanai ground floor slab

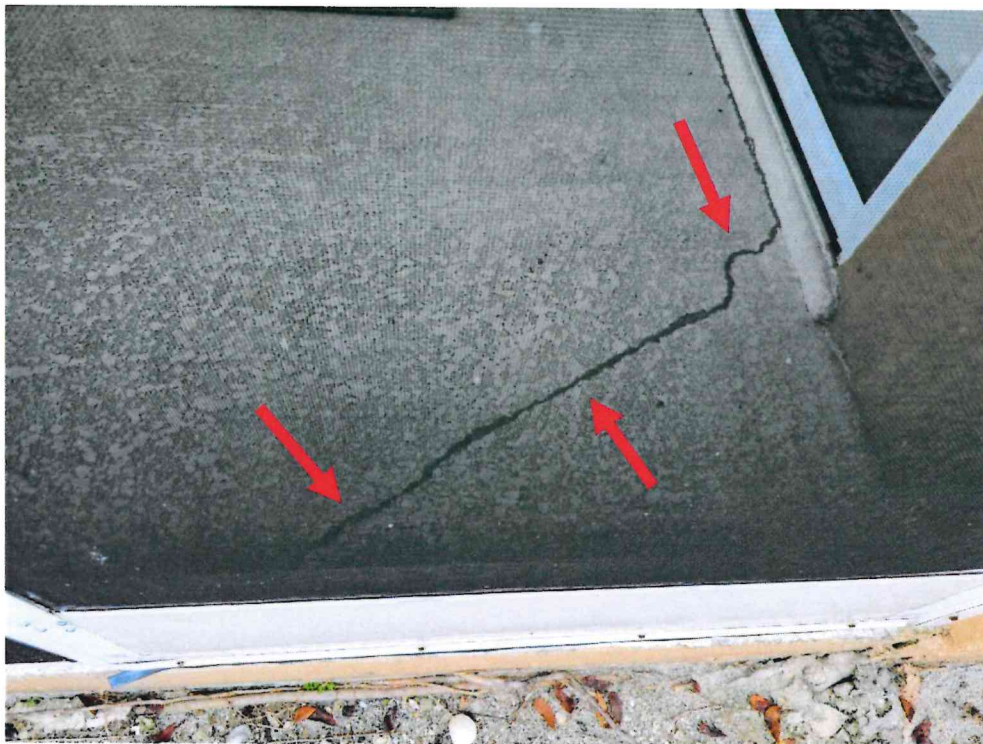
Unit 23013 – Typical crack lanai ground floor slab
